ASBESTOS MANAGEMENT SURVEY

St. Francis Centre Church Hall
Somerset Road, Linford
Stanford-le-Hope
SS17 0QA

Project Reference: APR 21465
Client Reference: St Francis Centre
Prepared By: Andrew Large
Report Issue Date: 28th May 2012

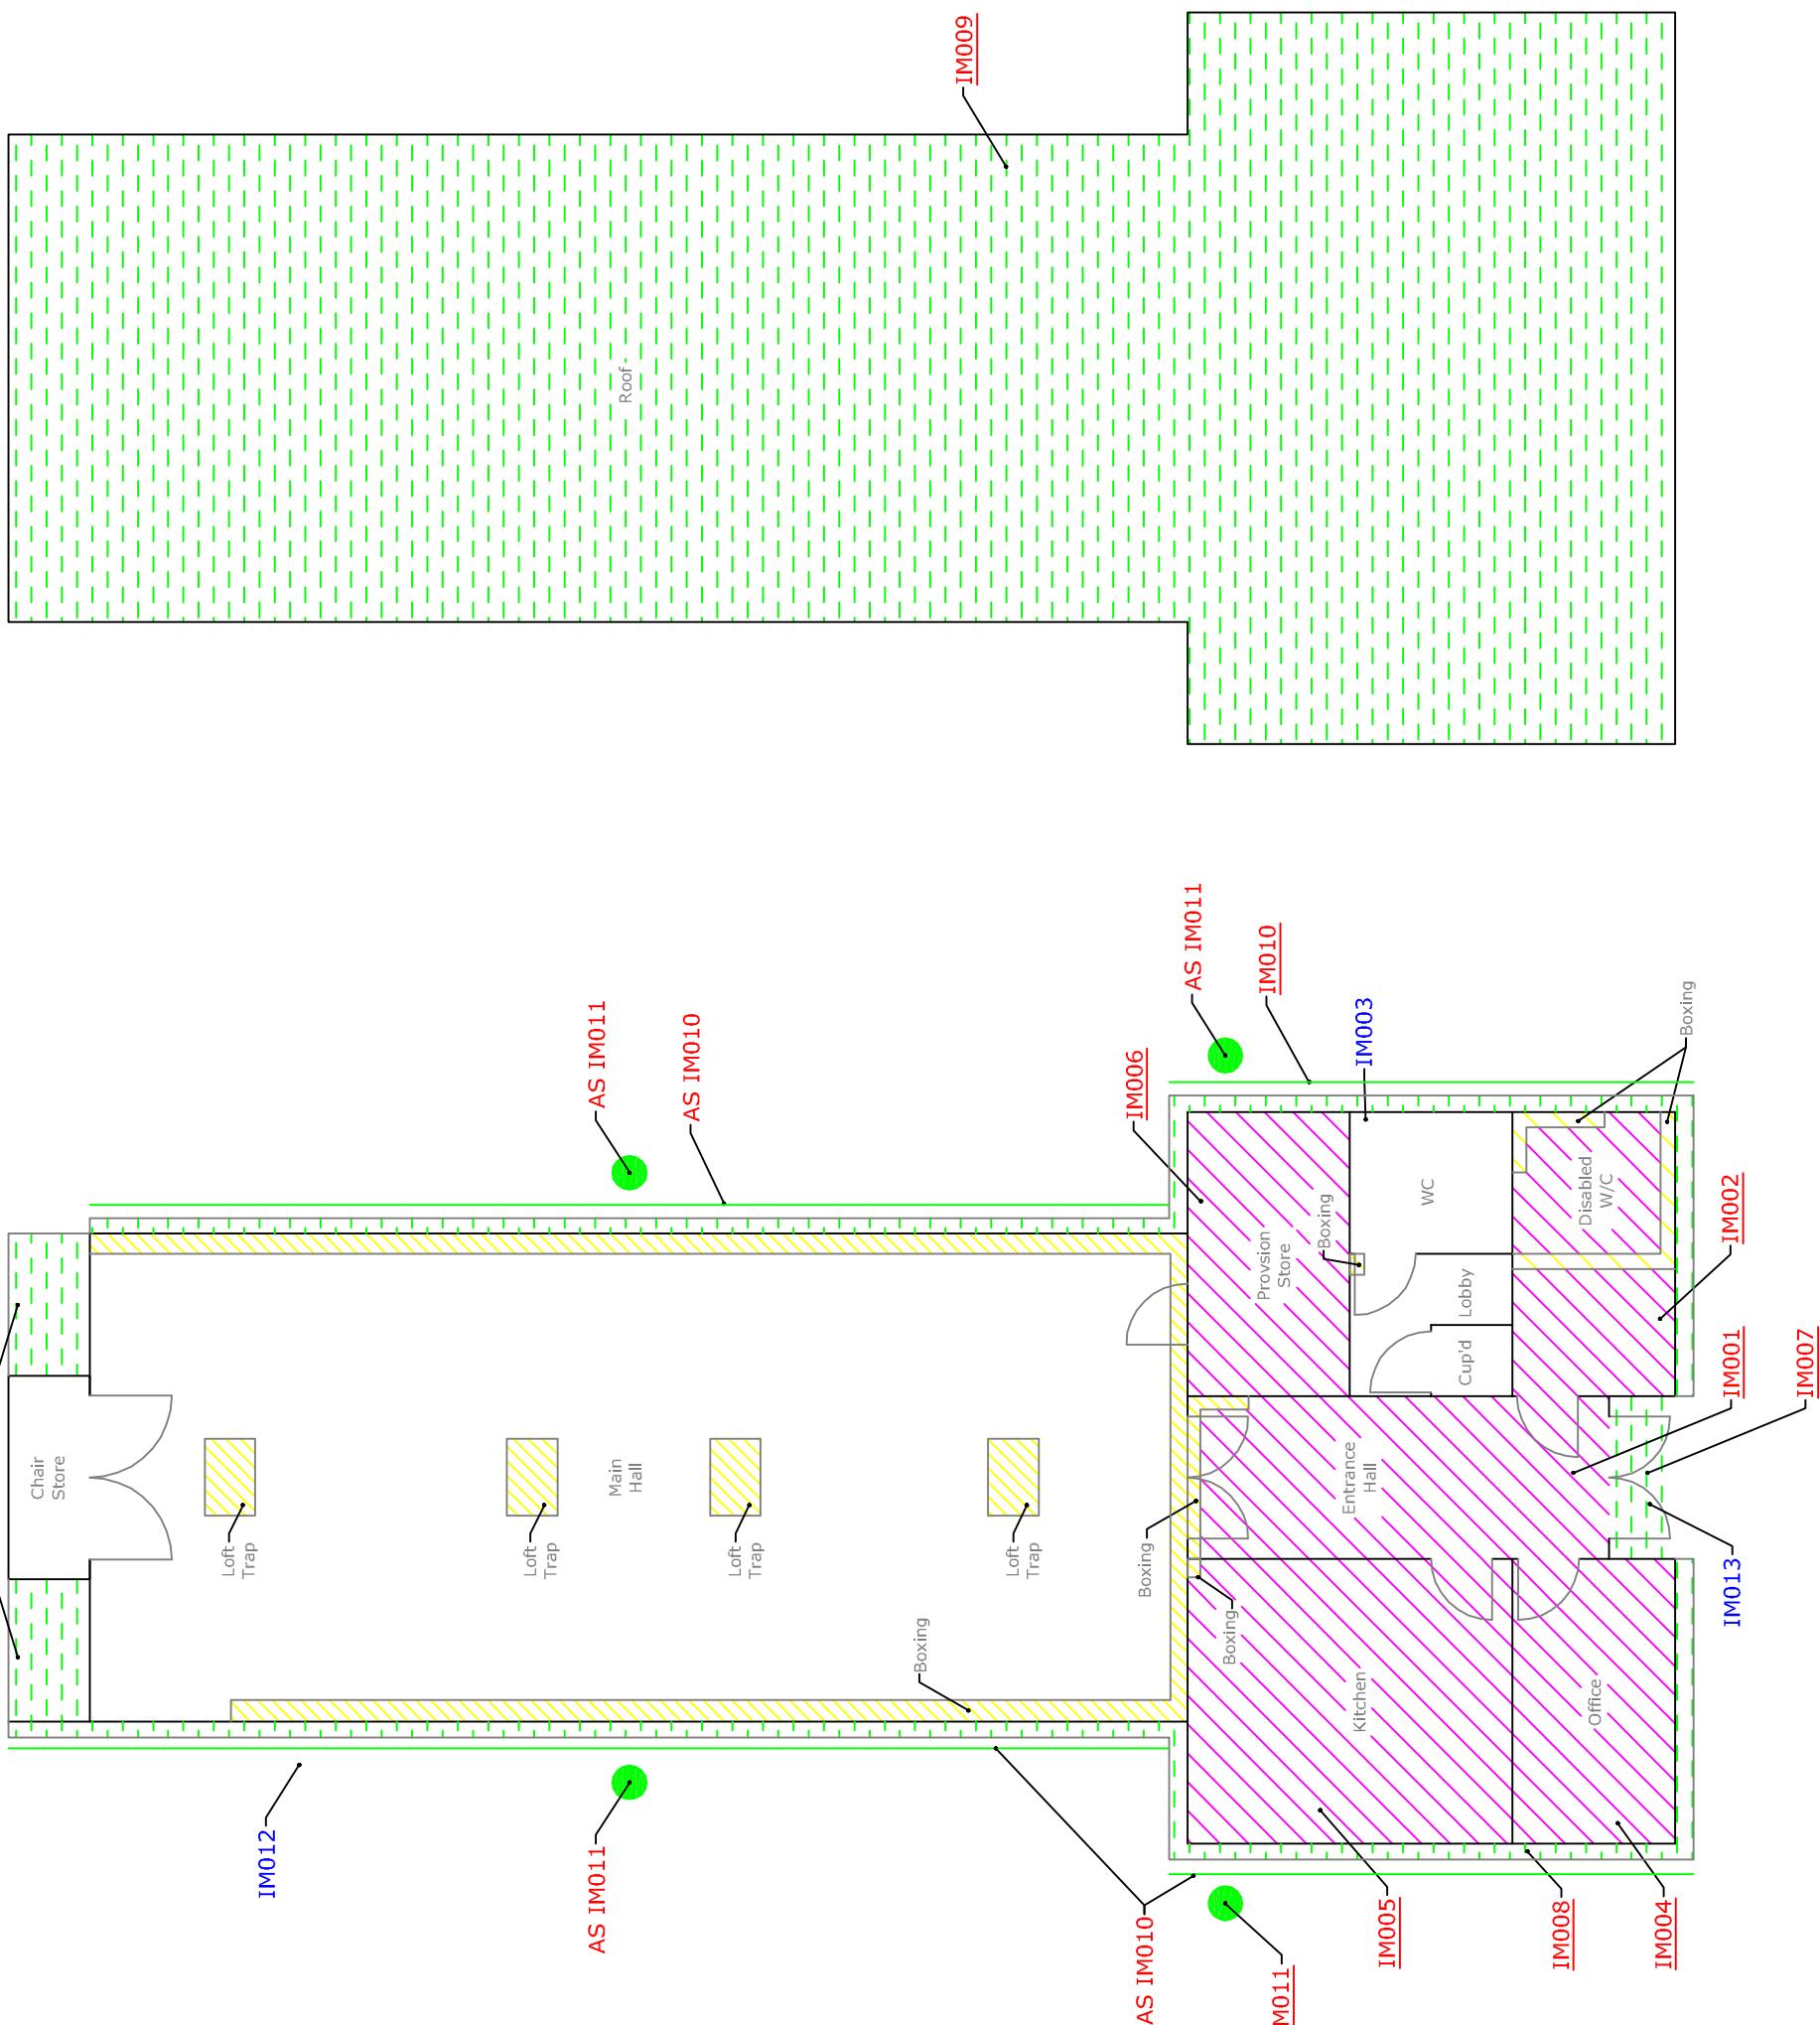
<p>This drawing must be viewed and read in conjunction with the Asbestos Survey Report for:</p>	
<p>St Francis Centre Junction Lower Crescent And Somerset Road Stanford-Le-Hope SS17 0QA</p>	
<p>PROPERTY TITLE</p>	
<p>Ref. No. APR21465</p>	
<p>Ref. No. APR21465</p>	<p>DRAWN DATED</p>
<p>Nos. 1/1</p>	<p>LM 21-05-2012</p>
<p>REV</p>	
<p>DRAWING FILE No. APR21465 St Francis Centre</p>
